TSN CAM/SPINDLE REPLACEMENT PROCEDURE

DATA SHEET: 008
DATE: 02/16

MODELS COVERED: TSN25D, TSN25A, TSN55, TSN125

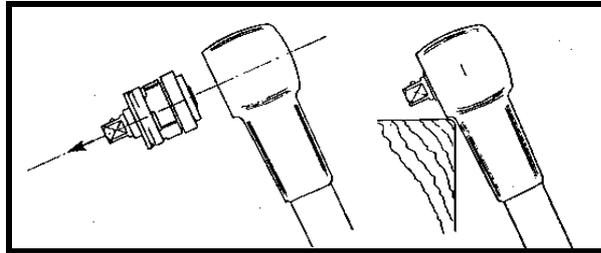
Fig 1

3. Gentle tapping of the head assembly against a wooden block (as per **fig1** below) will eject the *cam/spindle* assembly complete with *cover plate* and *front bearing* from the TSN head. This may also cause the spindle and pawls to be ejected from the cam (as per **fig2** below). If this occurs take care not to lose the pawls or pawl springs.
